Singapore Fish Farm Minimizes Adverse Effects of Algae Buildup with DPAsys.

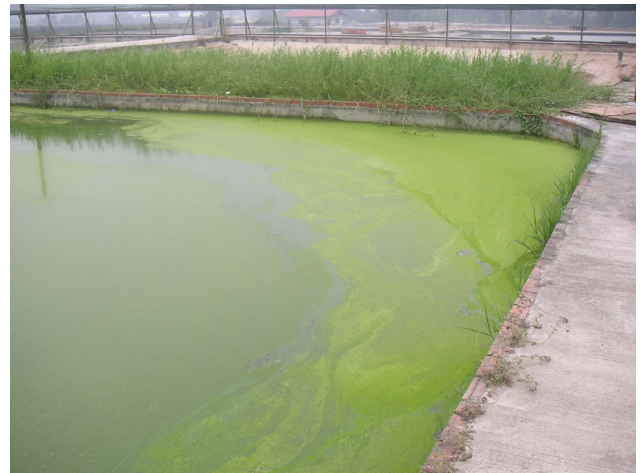
Figure 1: Before DPAsys treatment (above) – occurrence of "algae blooms" leads to heavy buildup of algae in surface waters of the pond.

Substances contributing to BOD become food for bacteria, and the more the bacteria feed on these, the more they also take in oxygen. Furthermore, if temperature and nutrient levels are optimum, there will be rapid algae growth, leading to "algae bloom." Algae blooms are likely to cause depletion of Dissolved Oxygen (DO) in fish ponds.

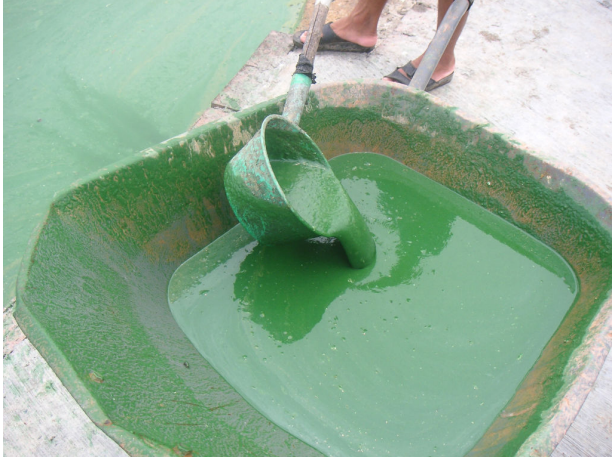
Figure 2: Before DPAsys treatment (above) - algae buildup scooped from a breeding pond and placed under closer observation

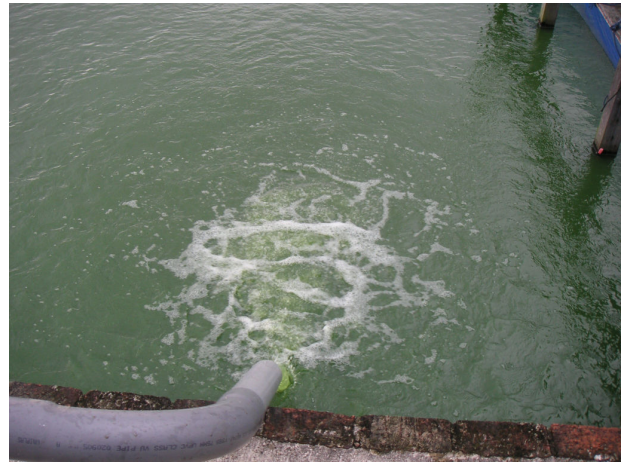
Figure 3: After DPAsys treatment (above)- Edges of the pond free of algae buildup and water surface displays higher transparency.

In October 2006, more than a month after DPA system was installed in the water circulation system, it was observed that algae buildup in the outdoor breeding pond has been mitigated. The thick layer of algae is no longer present. In contrast, the water surface displays much higher transparency and clarity as shown below.

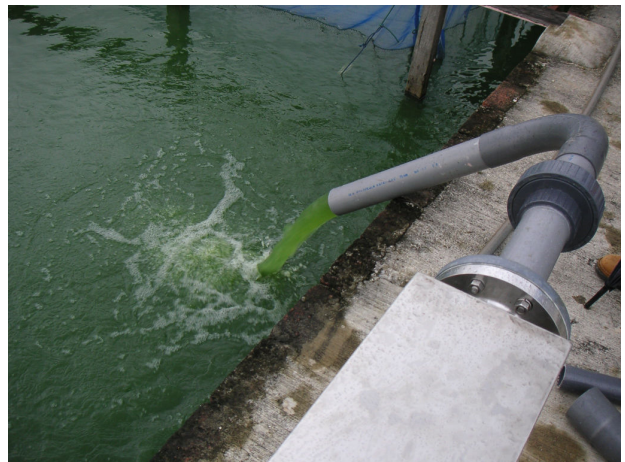
Figure 4: Right-hand-side shows a unit of the DPA system employed in the circulation flow.

Firstly, site survey and engineering audit were conducted by SIF Technologies to identify key problems. Subsequently, on 30th August 2006, a full-scale trial was initiated to introduce DPA system into a pond which measures 30 m x 18 m x 2.5 m and contains approximately 1, 500, 000 liters of water. Optical recording equipment was used to document the effects of DPA system on the quality of water.
